**TITLE:** Presentation on San Leandro Marina Facilities Decommissioning Assessment

# **GHD Report for City of San Leandro San Leandro Marina**

## **Marina Facilities Decommissioning Assessment**

# Marina Facilities Decommissioning Assessment

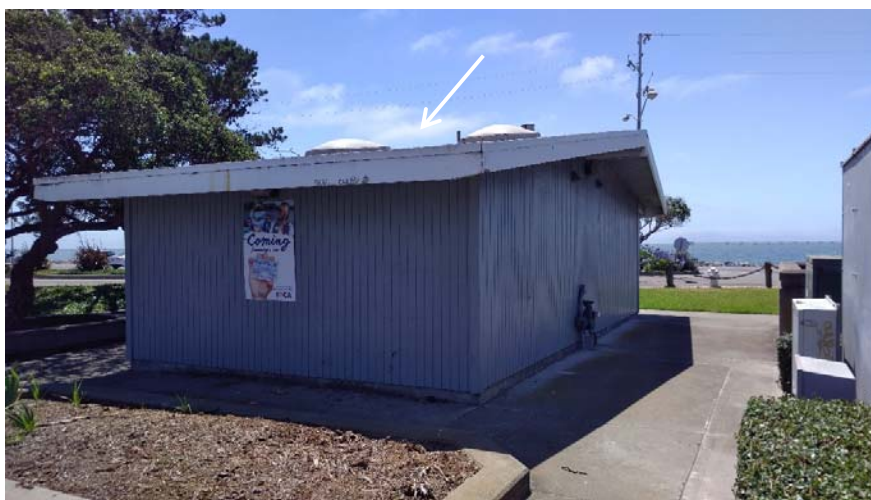
**Photograph 1** – Marina – Restroom A, B – Roof penetrations – Penetrations throughout (indicated by white arrow) reported to contain asbestos.

GHD recommends that materials reported to contain detectable concentrations of asbestos (Category I and II ACM, RACM, ACCM and/or Presumed ACM) should be removed by a licensed abatement contractor as described further in this report.

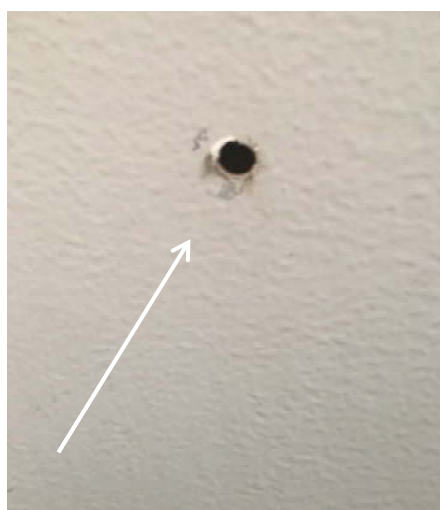
**Photograph 2** – Marina – Restroom E, F – Wall texture (white) – Sampled at wall systems (indicated by white arrow) reported to contain asbestos.

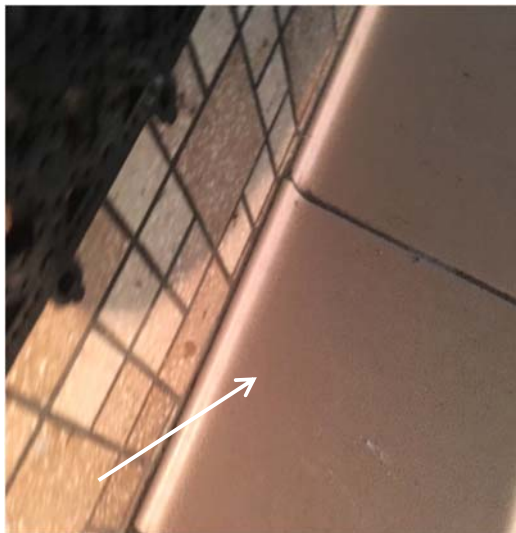
**Photograph 3** – Marina – Restrooms E interior – Ceramic tile mastic (tan) located underneath tile - associated with floor and wall systems (indicated by white arrow) reported to contain asbestos.

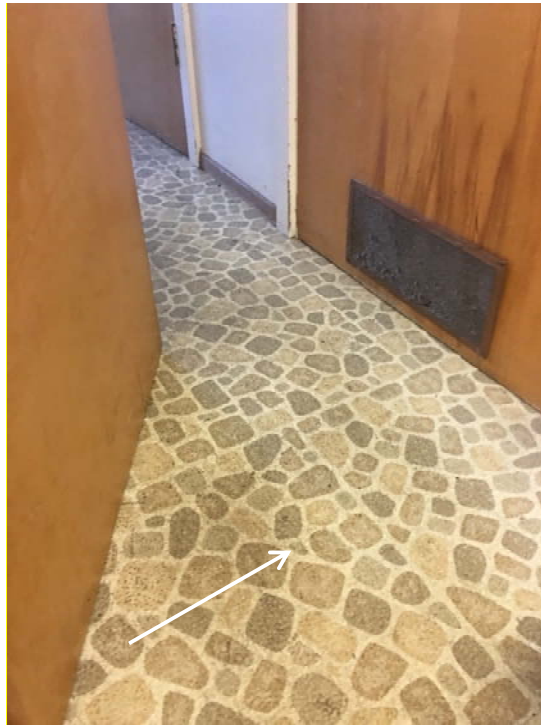
**Photograph 4** – Marina – Harbor Master's Office – Resilient sheet flooring (tan/gold), 12"x12" vinyl floor tile (not shown, located underneath RSF) (indicated by white arrow) both reported to contain asbestos.

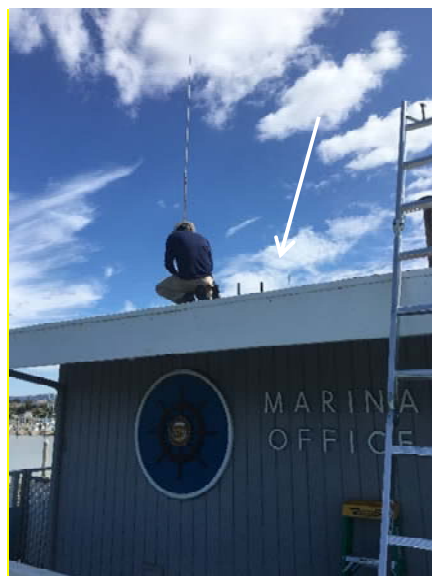
**Photograph 5** – Marina – Harbor Master's Office – Roof – Roof Penetrations throughout (grey and black) (typical, indicated by white arrow) reported to contain asbestos.

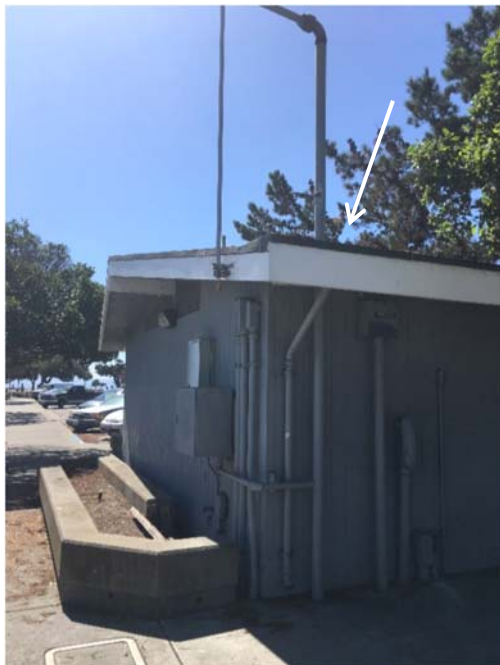
**Photograph 6** – Marina – Restroom F – Roof – Roof Caulk (white/grey) (typical, indicated by white arrow) at penetrations throughout reported to contain asbestos.

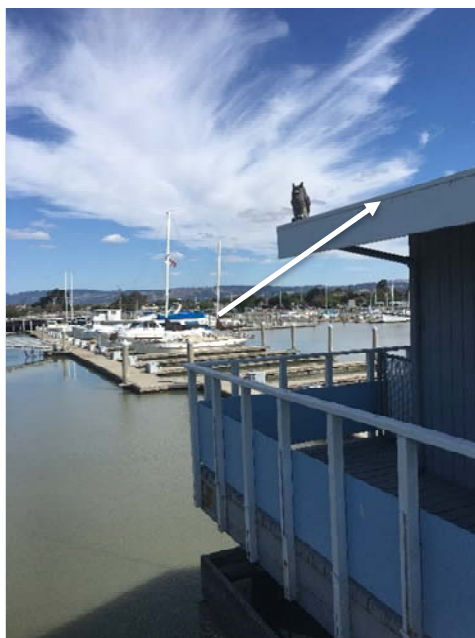
**Photograph 7** – Marina – Harbor Master's Office – Flashing and sealant (grey) (typical, indicated by white arrow) and reported contain asbestos.

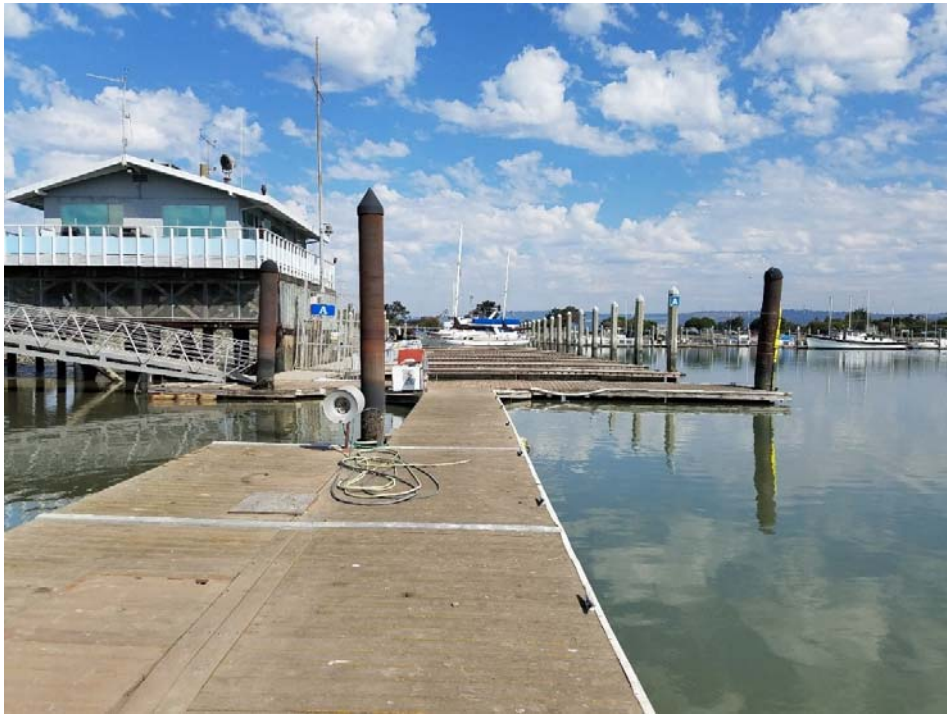
The floating docks just south of Pier A was originally the refueling dock that has been decommissioned. It was constructed of approximately 1,760 square feet of plastic lumber but is in poor condition and does not appear to be salvageable. There is a significant and noticeable deflection and rebound while walking on the refueling dock.

There are four steel guide piles at the old refueling dock and they appear to be in good condition without any noticeable corrosion or section loss. These piles are expected to be fairly straightforward to remove in one piece, and are valuable as scrap metal.

Photo 1 - Plastic lumber refueling dock with steel guide pile

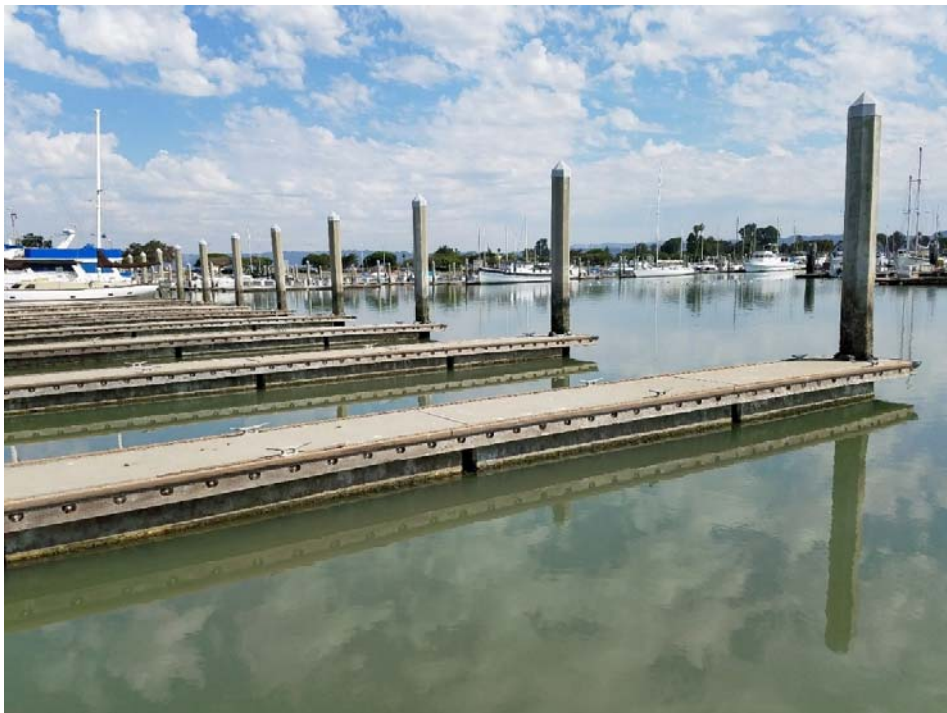
Piers A through H were renovated in 1990 where existing timber floating docks were removed and replaced with new concrete floating docks. There are approximately 58,520 square feet of concrete floats and fingers, and are generally in good working condition and salvageable.

Photo 2 - Pier A -- Typical Concrete Float Condition

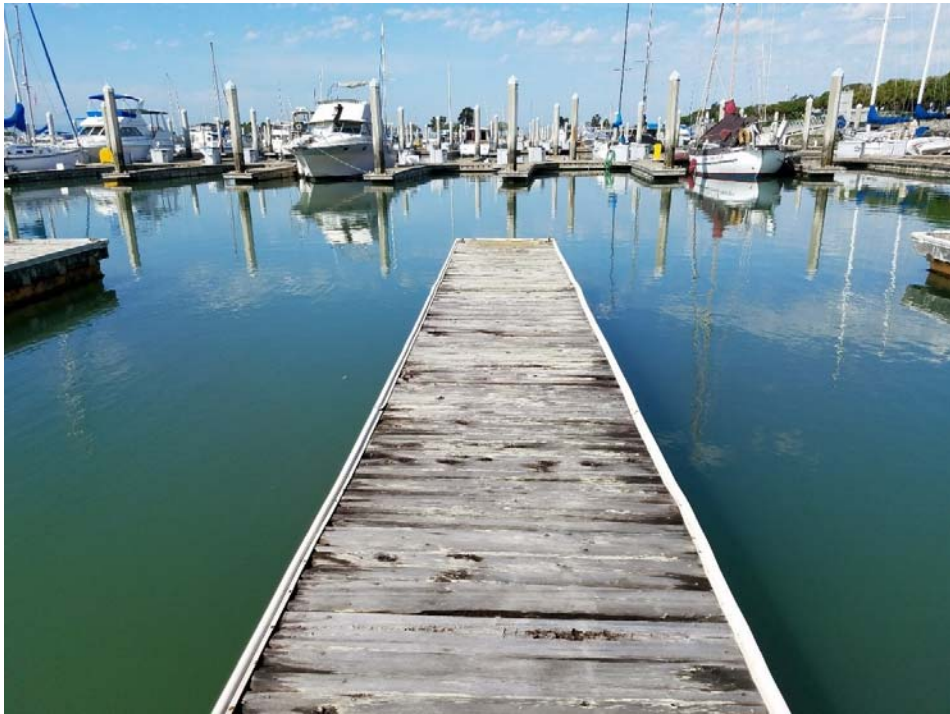
The remaining Piers J through Q consist of timber floating docks and fingers. There are approximately 48,700 square feet of timber floating docks and generally are in poor condition. Piers P and Q were considered unsafe and are currently closed to the public. While the remaining timber docks are in use, they do not appear to be salvageable.

Photo 3 - Typical Condition of Timber Finger

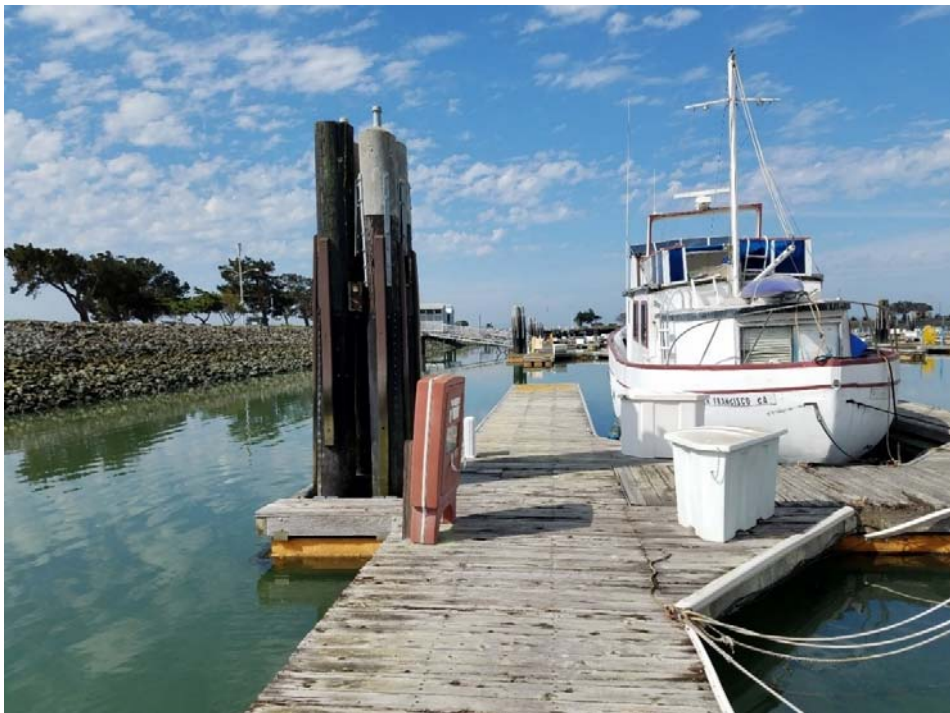
At the remaining Piers J through Q, instead of individual guide piles, four timber piles were bundled together to form a single structure (dolphin) to secure the docks. Many piles appear to have been repaired in the past, such as fiberglass jackets to prevent further section loss, or new steel or concrete caps to restore the upper portion of the timber piles. Per the as-built drawings, the dolphins are 16 inches in diameter and 50 feet long, and comprised of 112 individual piles.

Photo 4 - Typical timber dolphin and floating dock. Note fiberglass jacket and concrete cap on the piles.

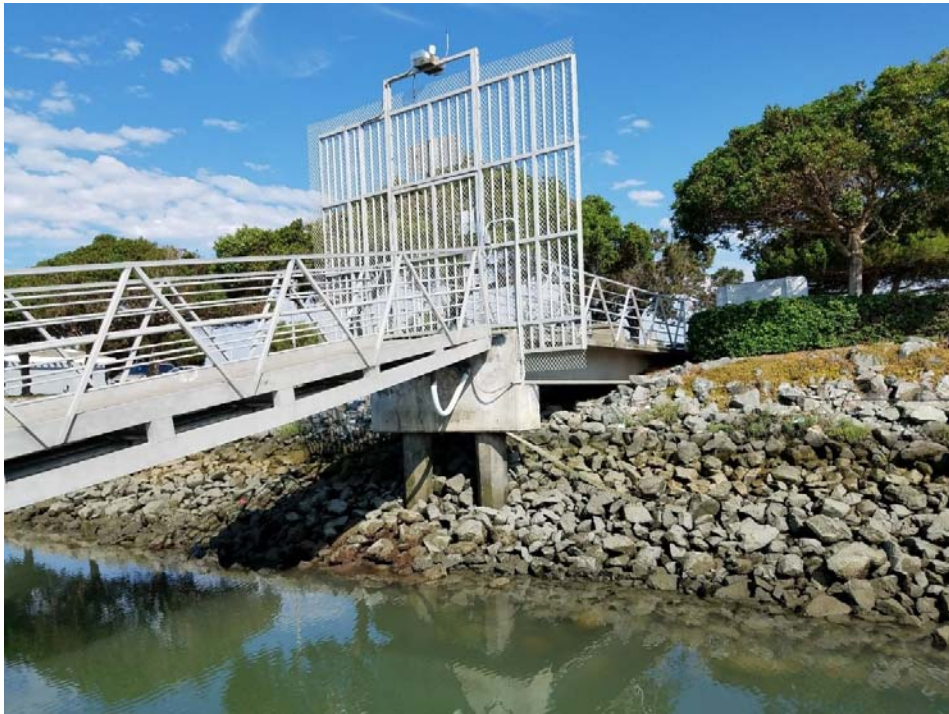
All ten gangways were replaced during the 1990 renovation and are 38-feet long aluminum structures. They appear to be in serviceable condition and without any noticeable deterioration or corrosion.

Photo 5 - Concrete Access Pier and Aluminum Gangway

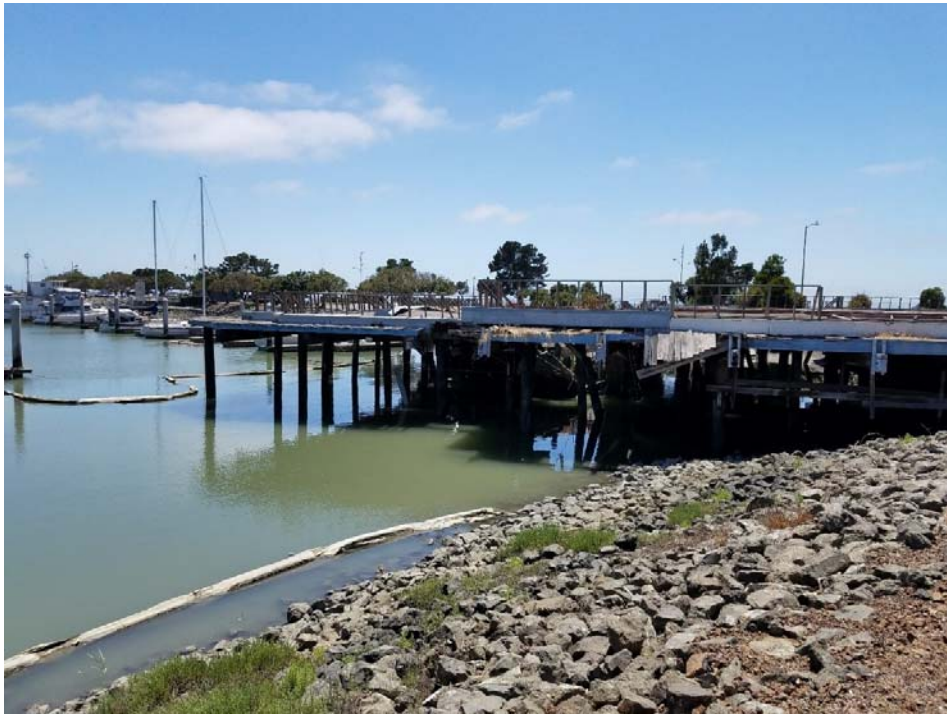
North of Pier A is what remains of the Blue Dolphin Restaurant. The previous building owner closed his business and left the building to rot and all that remains are the piles and pile-supported foundation. Due to the highly deteriorated state, it was not safe to inspect or quantify the piles.

The timber piles are not anticipated to be salvageable and due to deterioration it may be difficult to completely remove the piles without damage.

Photo 9 - Blue Dolphin Restaurant Foundation

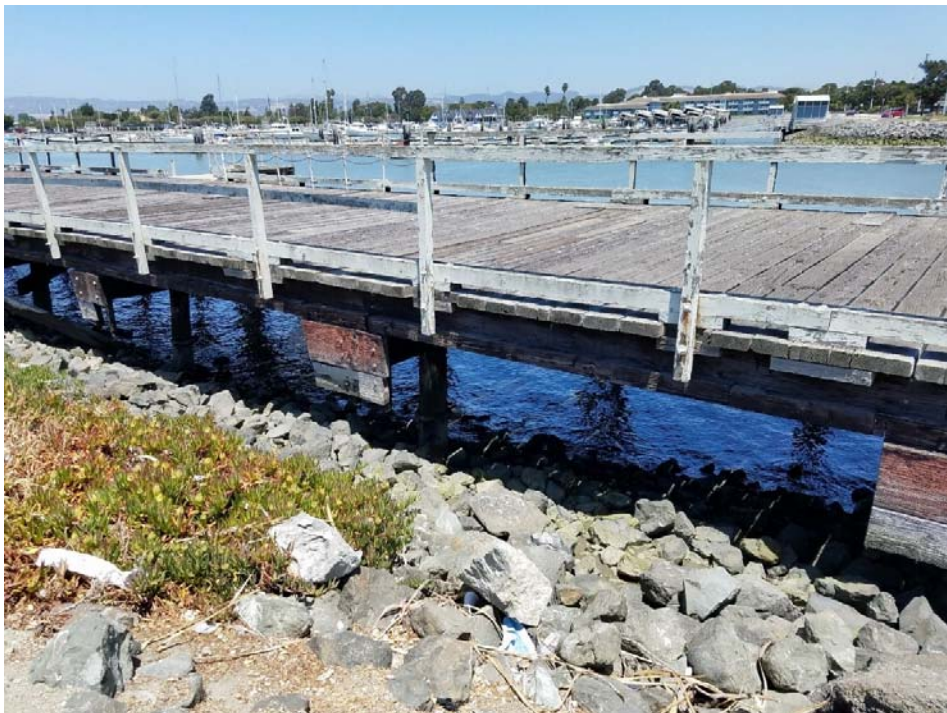
In addition, there are a two other structures supported by piles over the water, namely the Blue Dolphin Restaurant and a former observation deck (now closed), located north and south of Pier A, respectively. The observation deck was heavily damaged by fire, with only the foundation and piles still remaining.

Photo 10 - Closed Observation Deck

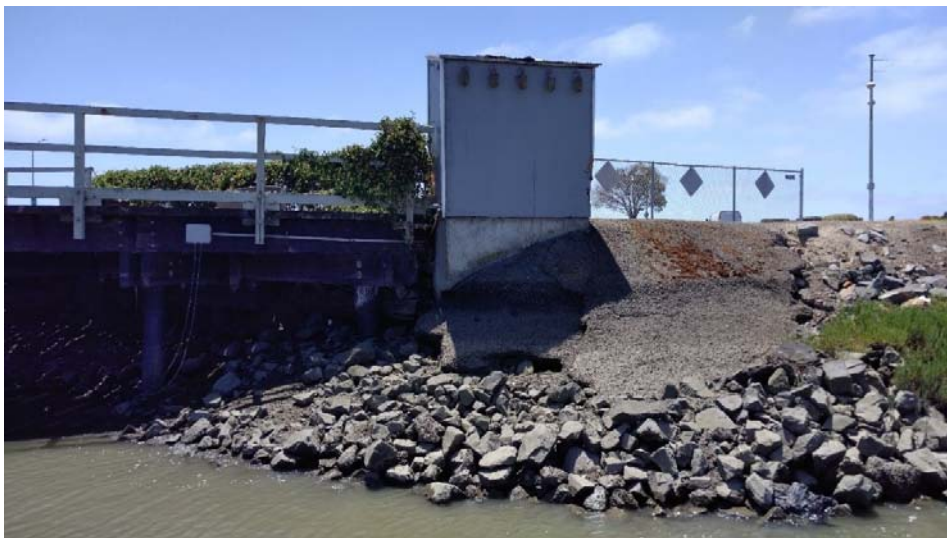
The refueling dock has been served by an on-shore plywood shed (approximately 6'L x 4'W x 8'H) containing electrical panels and pump controllers for pumps and tanks that no longer exist. The entire shed will be demolished to its foundation. The demolition shall include the removal of electrical panels, switches, light fixtures, controllers, and other related appurtenances, including the conduit and conductors attached to the outside and underside of the pile-supported deck.

Photo 14 - Plywood Shed and Pile-Supported Closed Observation Deck
